FIA Formula 3 Regional Championships, Technical Bulletin no. 002/20

OBJECT: Powerbox, junction loom to avoid electrical failure on PIN 7A PBox

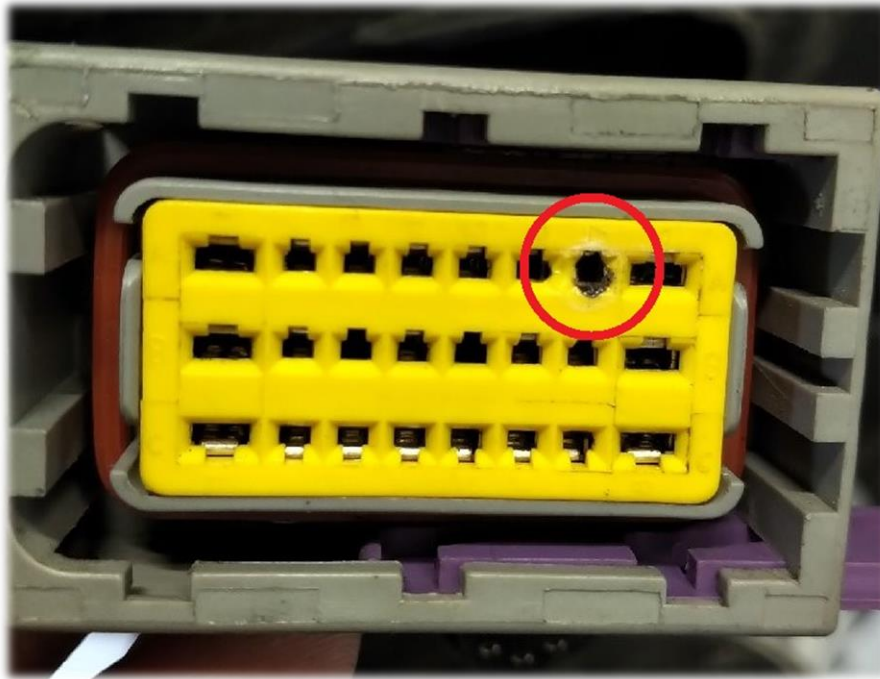
Fig.4: PIN 7A failed, chassis loom side.

Please find here below a picture of the PIN 7A failed on chassis loom (Fig.4) and Powerbox (Fig.5) side.

Before to install the new junction loom it's important to check the condition of PIN 7A on both terminations (Powerbox and chassis loom).

In case you find it failed even just on one side, please get in contact with Tatuus Racing.
